**Flood Control Project Maintenance
Levee Inspections**
LMA District Cover Sheet
Spring 2012 Levee Inspection Results

Reclamation District No. 2085 Kasson

Levee Inspection Report By Mile - Spring 2012

Waterway				Bank	Unit Miles	Inspection Start/End	Inspector
Unit No. 01 San Joaquin River				Left	5.20	05/16/2012 05/16/2012	Max Khashchuk

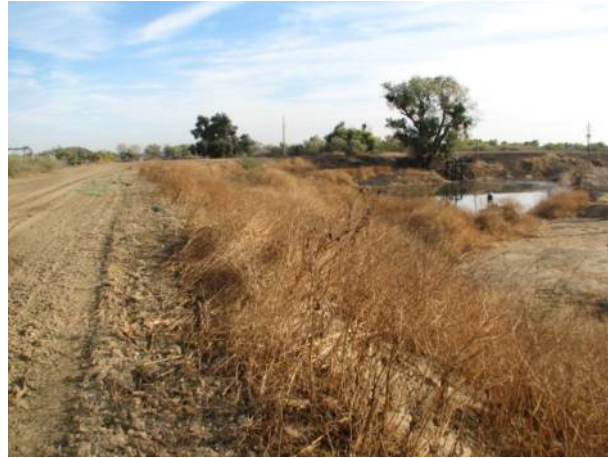
Levee Mile Report Line	4
Start Levee Mile	0.41
End Levee Mile	0.64
Location	Land Side
Category	Earthen Levee
Item	Vegetation

Tall weeds remain on the landside levee slope.

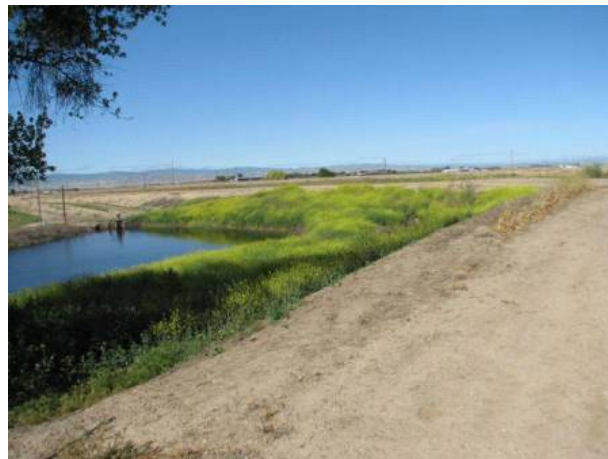
Levee Mile Report Line	4
Start Levee Mile	0.41
End Levee Mile	0.64
Location	Land Side
Category	Earthen Levee
Item	Vegetation

04/28/2011 Weeds taller than 12" inhibit visibility of landside slope and toe.

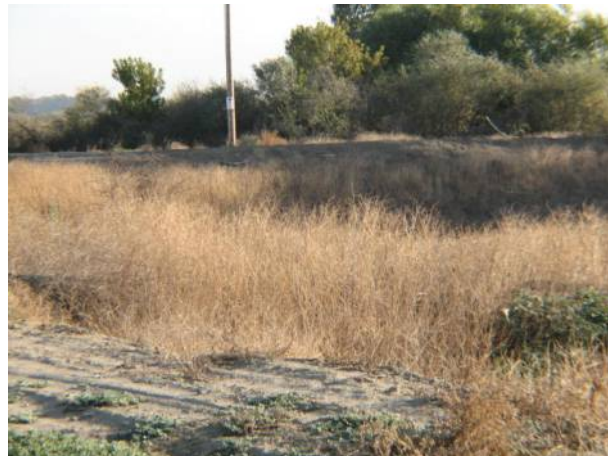
Levee Mile Report Line	4
Start Levee Mile	0.41
End Levee Mile	0.64
Location	Land Side
Category	Earthen Levee
Item	Vegetation

11/03/2011 Updated photo vegetation issue still remains on landside.

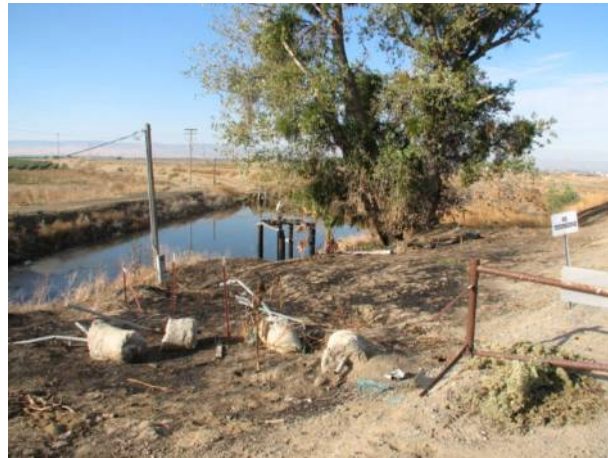
Levee Mile Report Line	5
Start Levee Mile	0.47
End Levee Mile	0.47
Location	Water Side
Category	Earthen Levee
Item	Encroachments

Drainage discharge pipe penetrates levee with no closure device.

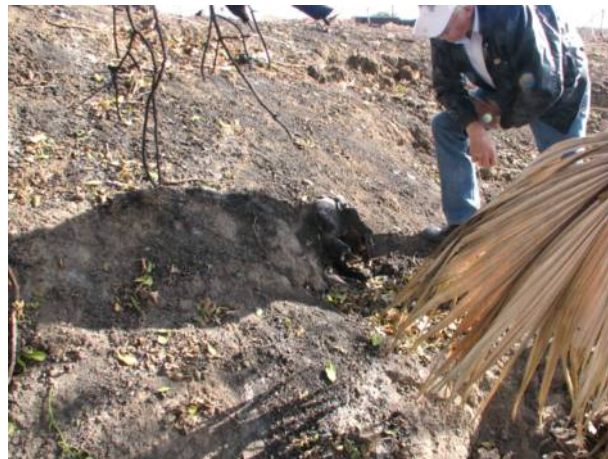
Levee Mile Report Line	5
Start Levee Mile	0.47
End Levee Mile	0.47
Location	Water Side
Category	Earthen Levee
Item	Encroachments

Opening on landside appears to consist of melted poly pipe halfway up levee slope. Opening on waterside is heavily corroded steel pipe.

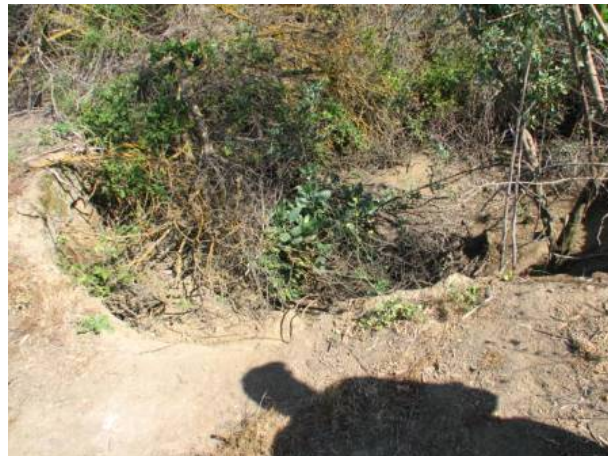
Levee Mile Report Line	5
Start Levee Mile	0.47
End Levee Mile	0.47
Location	Water Side
Category	Earthen Levee
Item	Encroachments

04/28/2011 Area around discharge pipe appears to be in an area of erosion. Area was found after weeds were cleared.

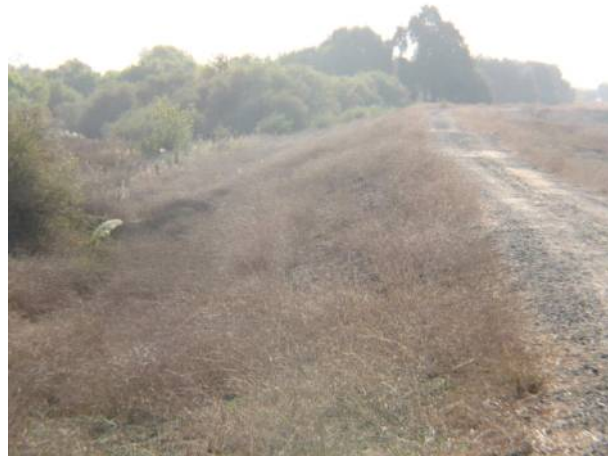
Levee Mile Report Line	7
Start Levee Mile	0.51
End Levee Mile	2.08
Location	Water Side
Category	Earthen Levee
Item	Vegetation
11/03/2011 Waterside vegetation management has not started yet.	
mkhashch_s_20120511_328.jpg

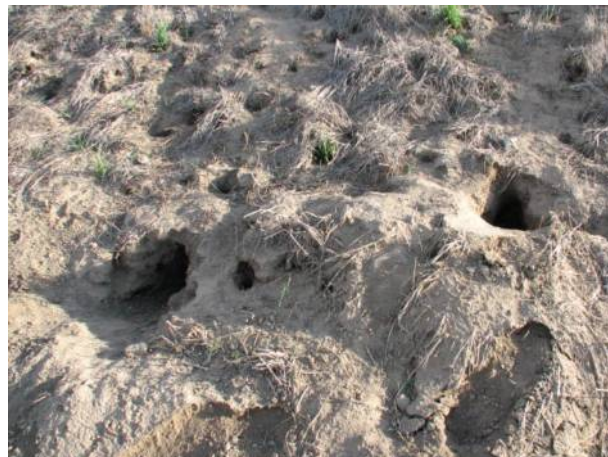
Levee Mile Report Line	10
Start Levee Mile	1.18
End Levee Mile	1.18
Location	Land Side
Category	Earthen Levee
Item	Animal Control
11/03/2011 Several burrows present.	
mkhashch_s_20120511_333.jpg

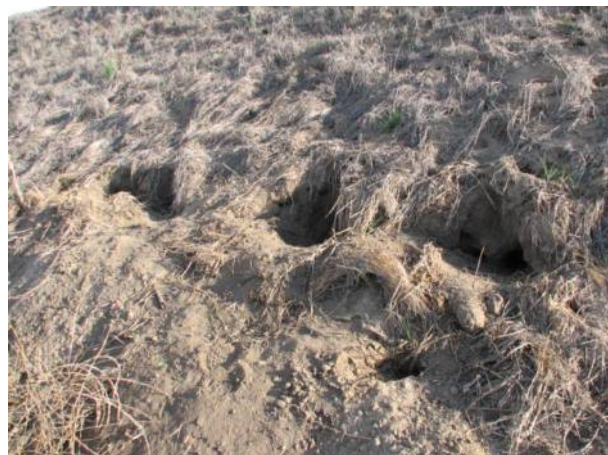
Levee Mile Report Line	10
Start Levee Mile	1.18
End Levee Mile	1.18
Location	Land Side
Category	Earthen Levee
Item	Animal Control
11/03/2011 Second photo more burrows in the same location.	
mkhashch_s_20120511_334.jpg

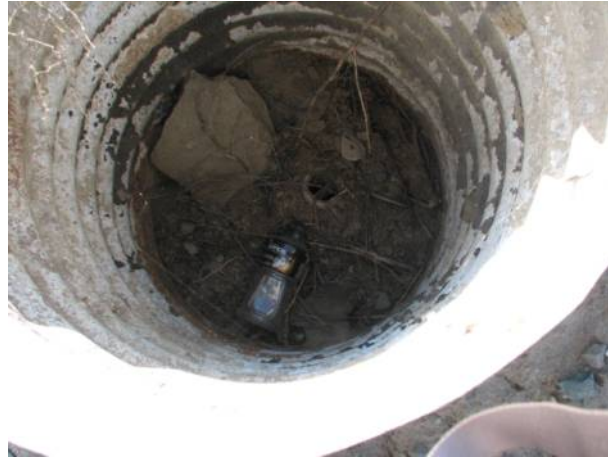
Levee Mile Report Line	12
Start Levee Mile	1.35
End Levee Mile	1.35
Location	Crown
Category	Earthen Levee
Item	Encroachments

Photo of anti siphon at waterside shoulder.

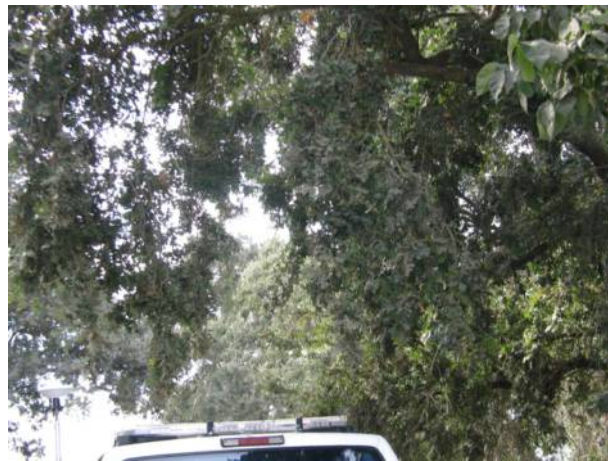
Levee Mile Report Line	15
Start Levee Mile	2.45
End Levee Mile	2.45
Location	Crown
Category	Earthen Levee
Item	Trim / Thin Trees

11/03/2011 Tree needs to be trimmed up to a minimum of 12' over the roadway.

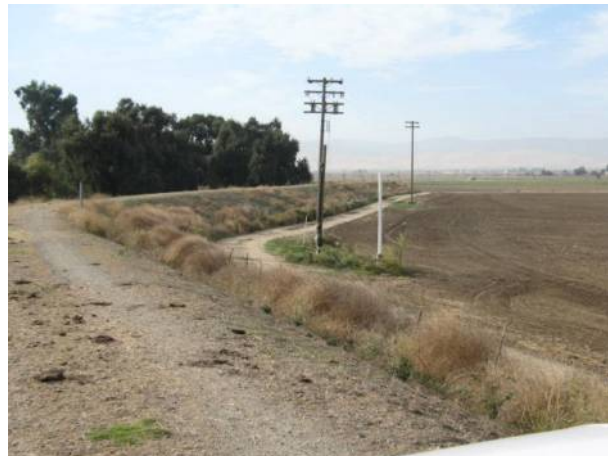
Levee Mile Report Line	17
Start Levee Mile	2.71
End Levee Mile	2.91
Location	Land Side
Category	Earthen Levee
Item	Vegetation

11/03/2011 Tumbleweed on landside slope and toe obscure visibility.

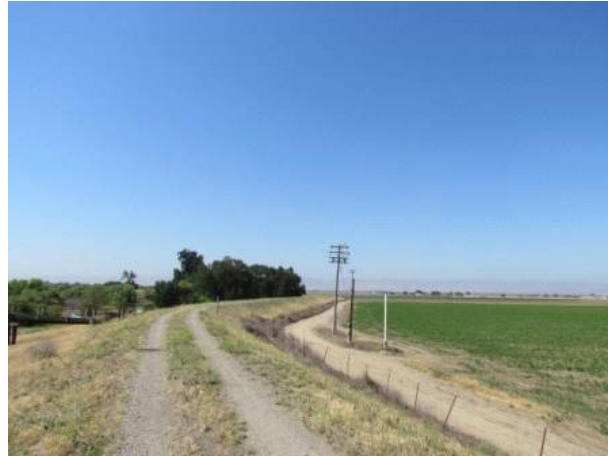
Levee Mile Report Line	17
Start Levee Mile	2.71
End Levee Mile	2.91
Location	Land Side
Category	Earthen Levee
Item	Vegetation

Most vegetation is removed; tumbleweeds are obstruct visibility of landside toe. 05/16/2012

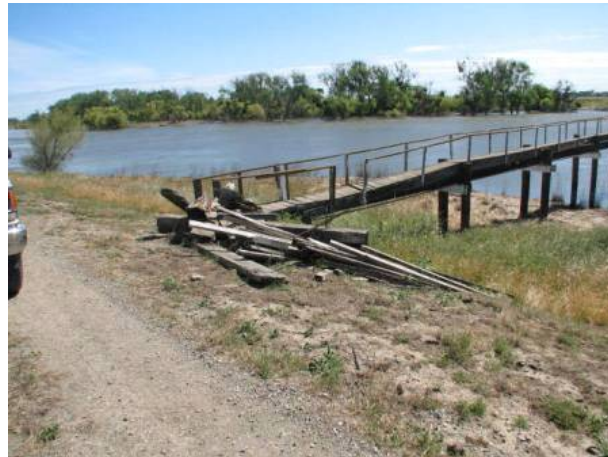
Levee Mile Report Line	18
Start Levee Mile	2.75
End Levee Mile	2.75
Location	Water Side
Category	Earthen Levee
Item	Encroachments

04/28/2011 Trash still present, item was noted in Fall 2010 inspection.

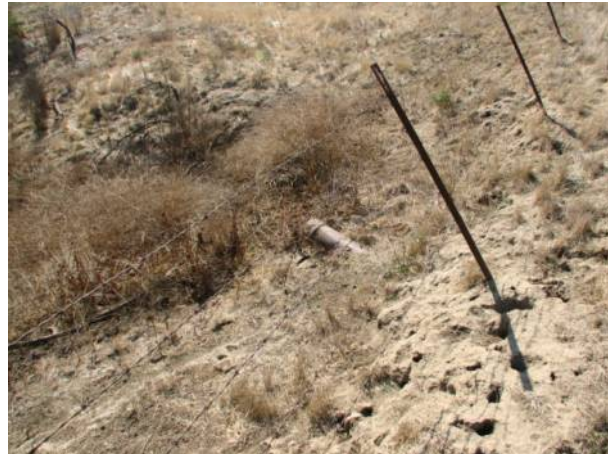
Levee Mile Report Line	20
Start Levee Mile	3.24
End Levee Mile	3.24
Location	Water Side
Category	Earthen Levee
Item	Encroachments

Photo of pipe penetration discharge off landside slope.

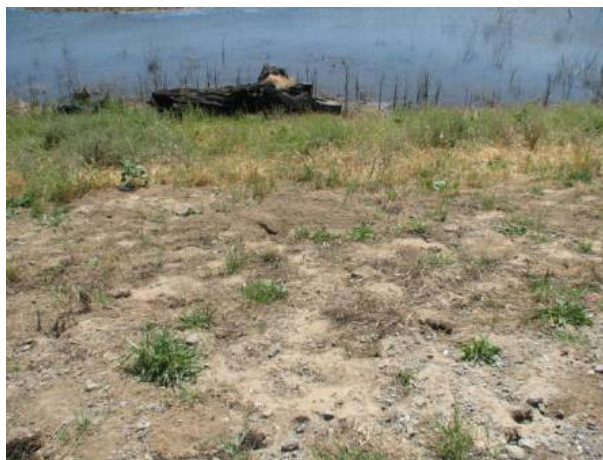
Levee Mile Report Line	21
Start Levee Mile	3.28
End Levee Mile	3.28
Location	Water Side
Category	Earthen Levee
Item	Animal Control
04/28/2011 Fresh burrow in center of picture, "porch" extends to the grass line.	
mkhashch_s_20120511_324.jpg

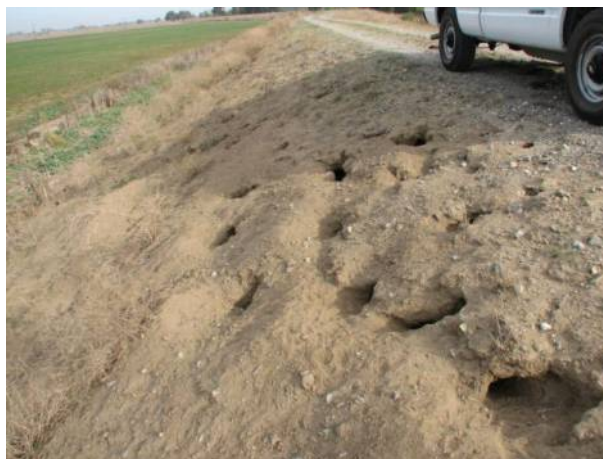
Levee Mile Report Line	22
Start Levee Mile	3.31
End Levee Mile	3.31
Location	Land Side
Category	Earthen Levee
Item	Animal Control
11/03/2011 Landside burrows.	
mkhashch_s_20120511_337.jpg

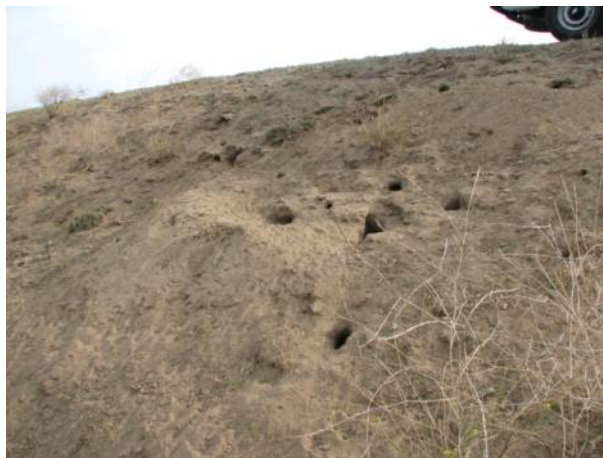
Levee Mile Report Line	22
Start Levee Mile	3.31
End Levee Mile	3.31
Location	Land Side
Category	Earthen Levee
Item	Animal Control
11/03/2011 More landside burrows at same location.	
mkhashch_s_20120511_338.jpg

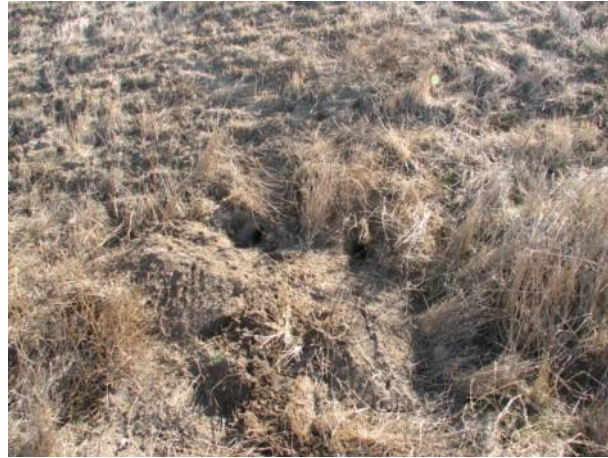
Rodent holes have been flagged for repair.

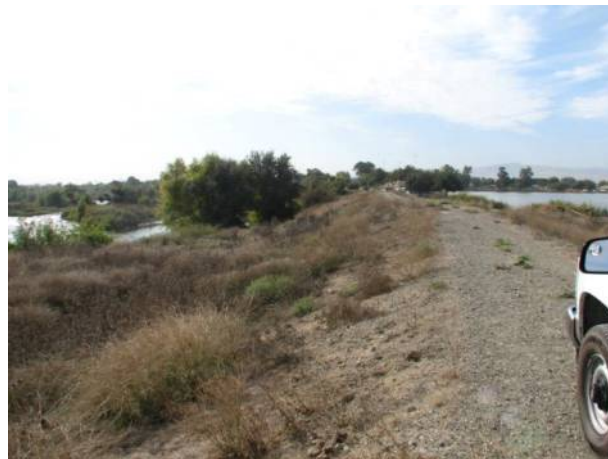
Levee Mile Report Line	28
Start Levee Mile	3.63
End Levee Mile	4.01
Location	Water Side
Category	Earthen Levee
Item	Vegetation

11/03/2011 Vegetation on water side is not being properly maintained. Top 20' from the hinge must be cleared.

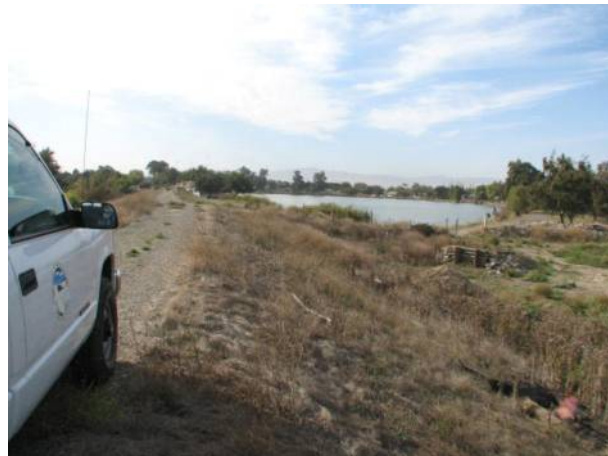
Levee Mile Report Line	29
Start Levee Mile	3.63
End Levee Mile	3.84
Location	Land Side
Category	Earthen Levee
Item	Vegetation

11/03/2011 Vegetation on landside must be controlled on the entire slope and 15' beyond the toe.

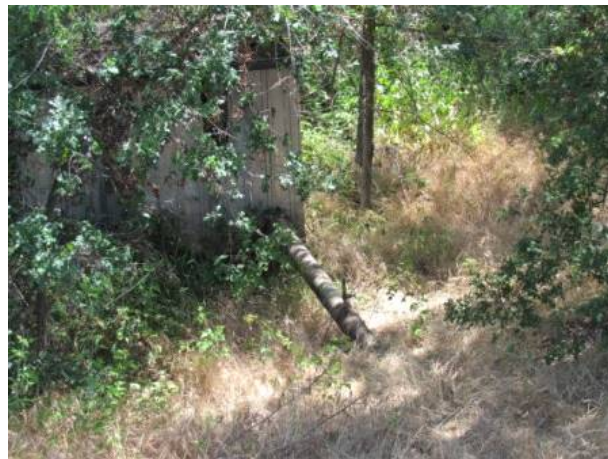
Levee Mile Report Line	33
Start Levee Mile	3.95
End Levee Mile	3.95
Location	Crown
Category	Earthen Levee
Item	Encroachments

View of pipe penetrating waterside slope.
05/16/2012

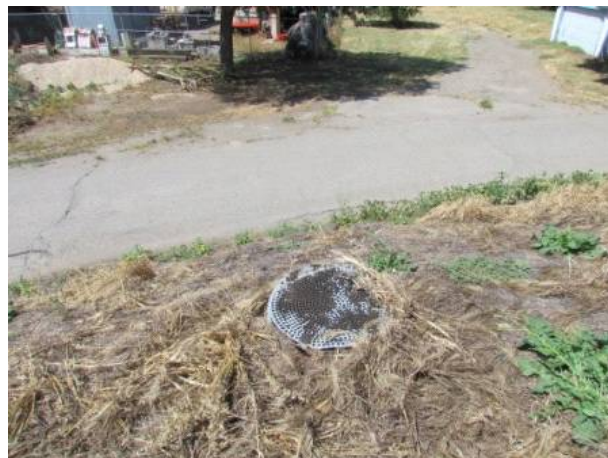
Levee Mile Report Line	33
Start Levee Mile	3.95
End Levee Mile	3.95
Location	Crown
Category	Earthen Levee
Item	Encroachments

View of siphon breaker valve on landside hinge.
05/16/2012

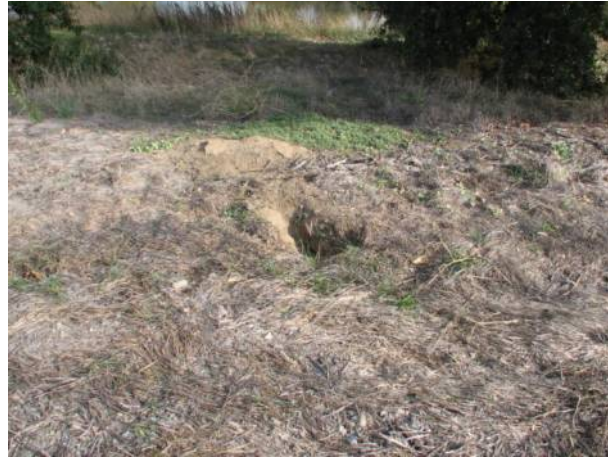
Levee Mile Report Line	34
Start Levee Mile	3.98
End Levee Mile	3.98
Location	Water Side
Category	Earthen Levee
Item	Animal Control
11/03/2011 Burrow on waterside.	
mkhashch_s_20120511_343.jpg

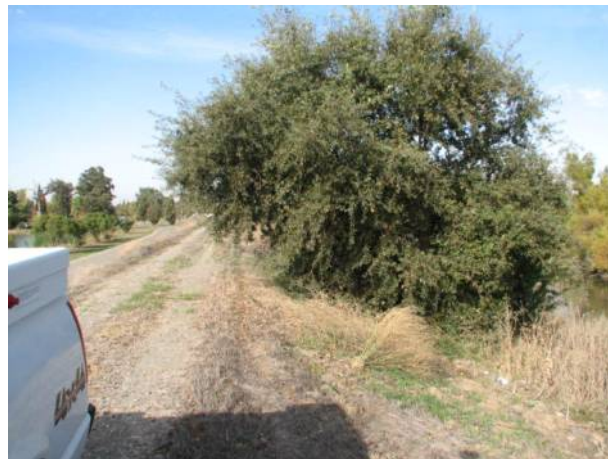
Levee Mile Report Line	35
Start Levee Mile	4.14
End Levee Mile	4.14
Location	Water Side
Category	Earthen Levee
Item	Trim / Thin Trees
11/03/2011 Tree on waterside needs to be trimmed up 5' over slope and up to a minimum of 12' over the roadway.	
mkhashch_s_20120511_327.jpg

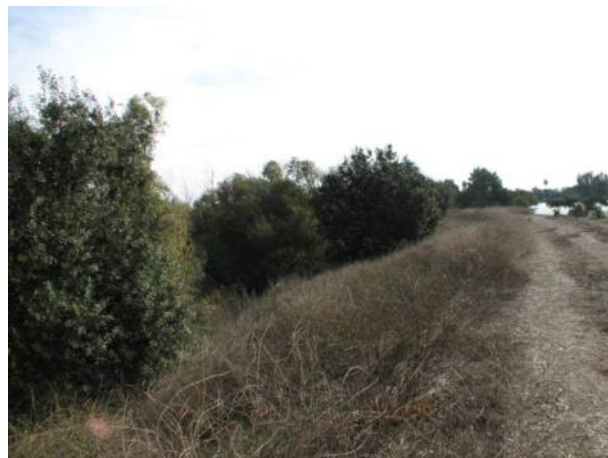
Levee Mile Report Line	36
Start Levee Mile	4.18
End Levee Mile	4.45
Location	Water Side
Category	Earthen Levee
Item	Vegetation
11/03/2011 Waterside vegetation needs to be maintained on the top 20' of the waterside slope.	
mkhashch_s_20120511_344.jpg

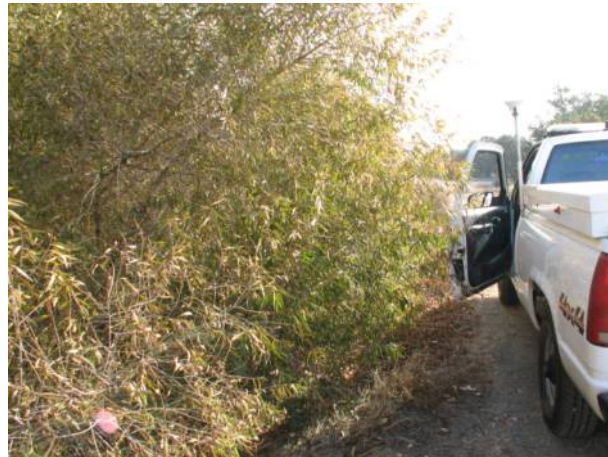
Levee Mile Report Line	40
Start Levee Mile	4.37
End Levee Mile	4.37
Location	Water Side
Category	Earthen Levee
Item	Trim / Thin Trees

11/03/2011 Tree needs to be limbed up to 5' above the ground on the waterside for visibility.

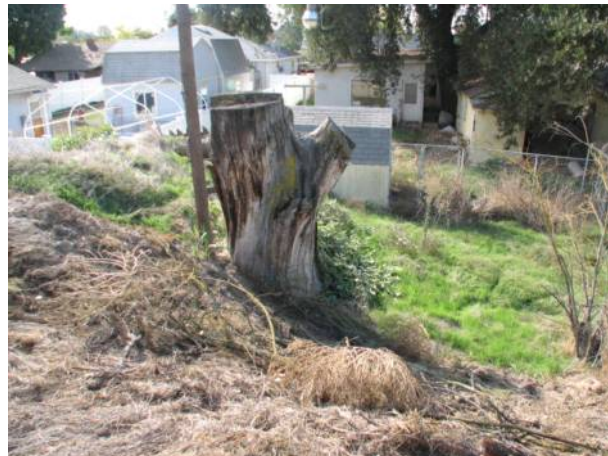
Levee Mile Report Line	41
Start Levee Mile	4.38
End Levee Mile	4.38
Location	Land Side
Category	Earthen Levee
Item	Trim / Thin Trees

11/03/2011 Large stump on landside slope.

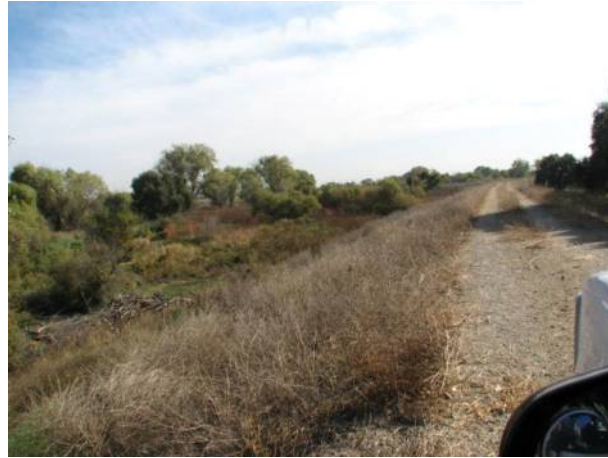
Levee Mile Report Line	42
Start Levee Mile	4.49
End Levee Mile	5.16
Location	Water Side
Category	Earthen Levee
Item	Vegetation
11/03/2011 Waterside vegetation needs to be managed on the top 20' of the slope.	
mkhashch_s_20120511_345.jpg

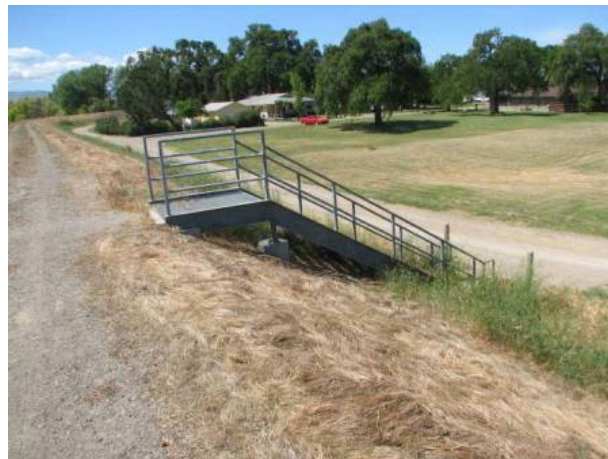
Levee Mile Report Line	44
Start Levee Mile	4.71
End Levee Mile	4.71
Location	Land Side
Category	Earthen Levee
Item	Encroachments
04/28/2011 Stairs on landside slope for monitoring station.	
mkhashch_s_20120511_331.jpg

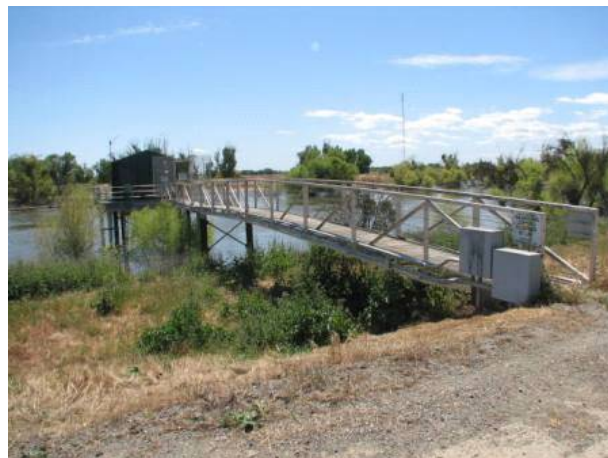
Levee Mile Report Line	45
Start Levee Mile	4.71
End Levee Mile	4.71
Location	Water Side
Category	Earthen Levee
Item	Encroachments
04/28/2011 Monitoring station.	
mkhashch_s_20120511_332.jpg

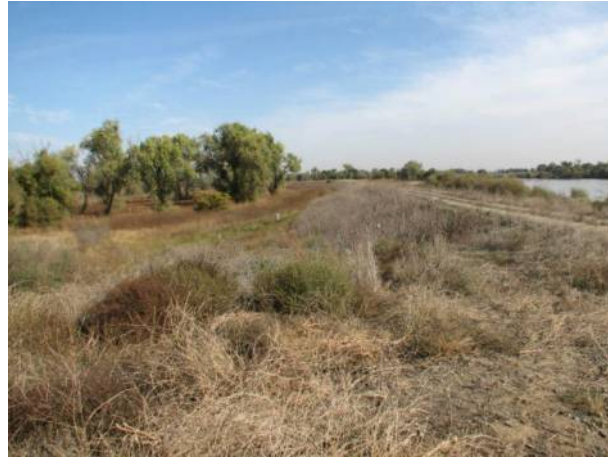
Levee Mile Report Line	46
Start Levee Mile	4.81
End Levee Mile	4.87
Location	Land Side
Category	Earthen Levee
Item	Vegetation
11/03/2011 Landside vegetation needs to be maintained for the full landside slope and 15' beyond the toe.	
mkhashch_s_20120511_346.jpg

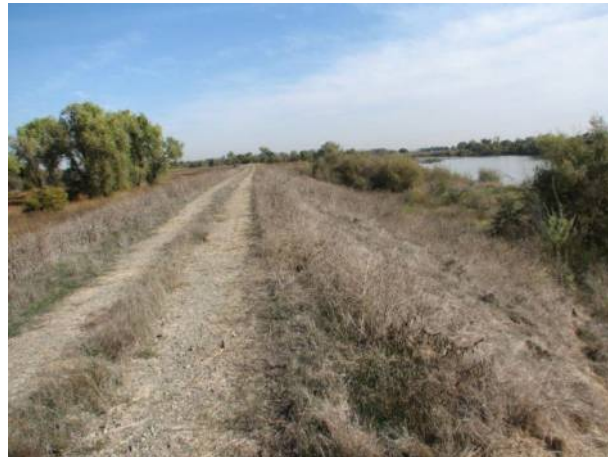
Levee Mile Report Line	47
Start Levee Mile	4.92
End Levee Mile	5.01
Location	Water Side
Category	Earthen Levee
Item	Vegetation
11/03/2011 Waterside vegetation has been sprayed, but needs to be removed so the top 20' of the slope is visible.	
mkhashch_s_20120511_347.jpg

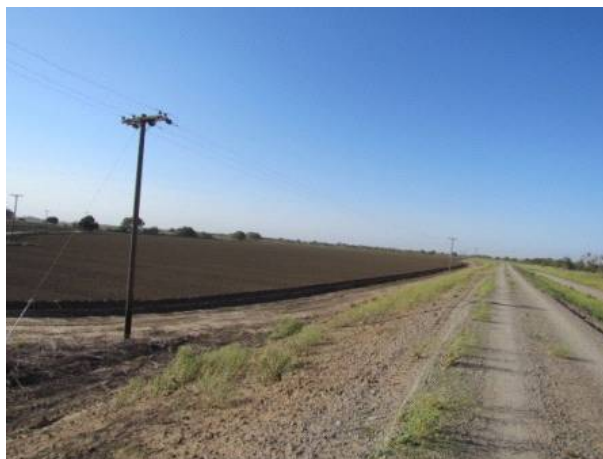
Levee Mile Report Line	2
Start Levee Mile	0.02
End Levee Mile	0.02
Location	Land Side
Category	Earthen Levee
Item	Vegetation

View of annual vegetation on landside slope.
05/24/2012

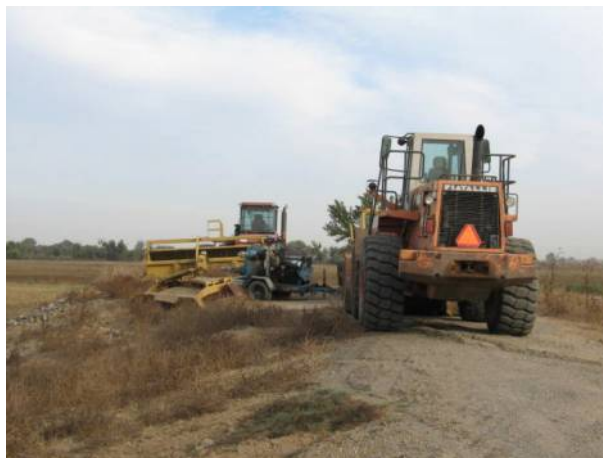
Levee Mile Report Line	3
Start Levee Mile	0.66
End Levee Mile	0.66
Location	Crown
Category	Earthen Levee
Item	Encroachments

11/03/2011 Heavy equipment being stored on the
levee crown at the end of the spur levee.

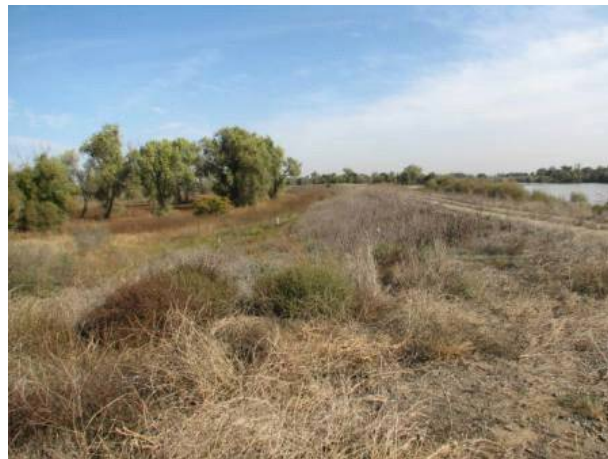
Levee Mile Report Line	1
Start Levee Mile	0.01
End Levee Mile	0.29
Location	Land Side
Category	Earthen Levee
Item	Vegetation

11/03/2011 Vegetation has been sprayed, but needs to be removed.

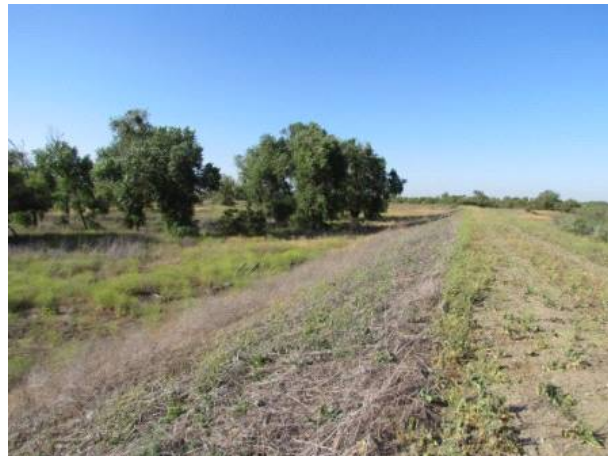
Levee Mile Report Line	1
Start Levee Mile	0.01
End Levee Mile	0.29
Location	Land Side
Category	Earthen Levee
Item	Vegetation

View of annual vegetation on landside slope.
05/24/2012

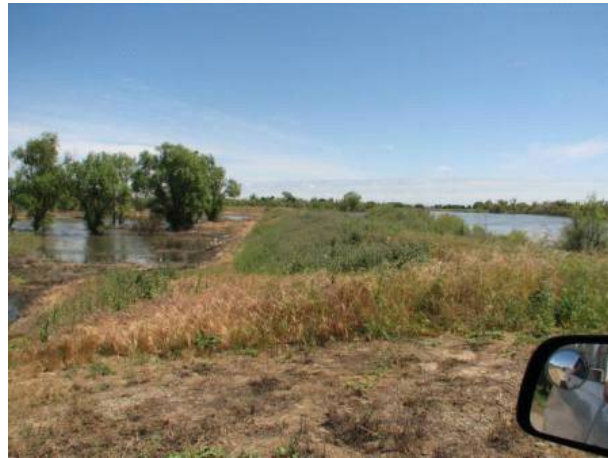
Levee Mile Report Line	2
Start Levee Mile	0.02
End Levee Mile	0.29
Location	Water Side
Category	Earthen Levee
Item	Vegetation
04/28/2011 Weeds taller than 12" are on both waterside slopes for the full length of the unit. Weeds prevent visibility of the slope and crown.	
mkhashch_s_20120511_349.jpg

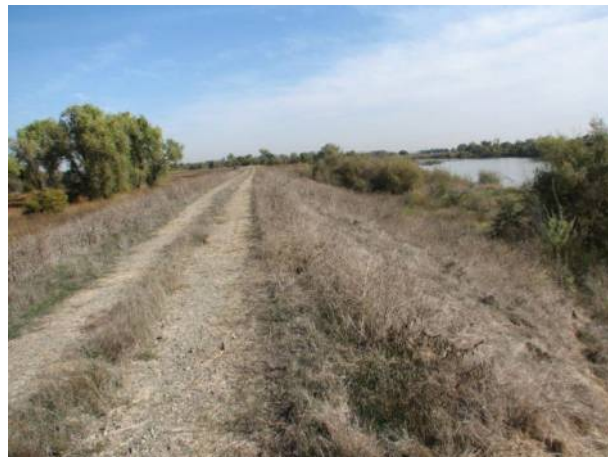
Levee Mile Report Line	2
Start Levee Mile	0.02
End Levee Mile	0.29
Location	Water Side
Category	Earthen Levee
Item	Vegetation
11/03/2011 Vegetation has been sprayed, but needs to be removed.	
mkhashch_s_20120511_350.jpg

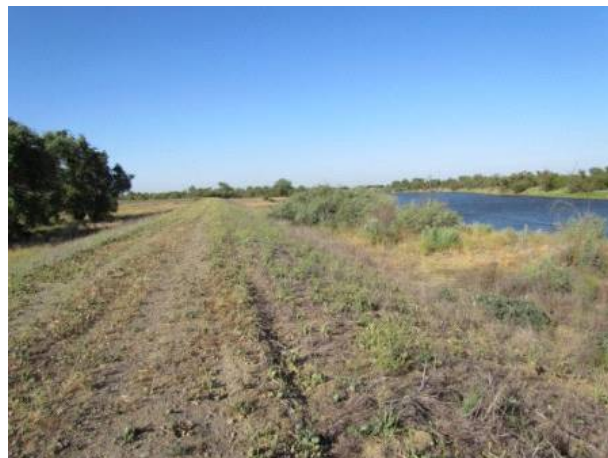
Levee Mile Report Line	2
Start Levee Mile	0.02
End Levee Mile	0.29
Location	Water Side
Category	Earthen Levee
Item	Vegetation
View of annual vegetation on waterside slope. 05/24/2012	
mkhashch_s_20120525_415.jpg
